# Manhole Inspection Summary

Manhole # S17E1\_005MH

Insp Date: **5/14/08 11:03 AM**

**Location** Address: **2025 inverness av**

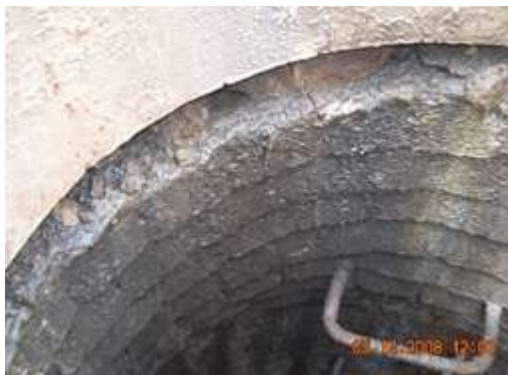
Defect 5

Infiltration: ☐ None ☒ **Joint** ☐ Cracks ☐ Mortar ☐ Roots ☐ Wall

infiltration @ chimney/frame joint

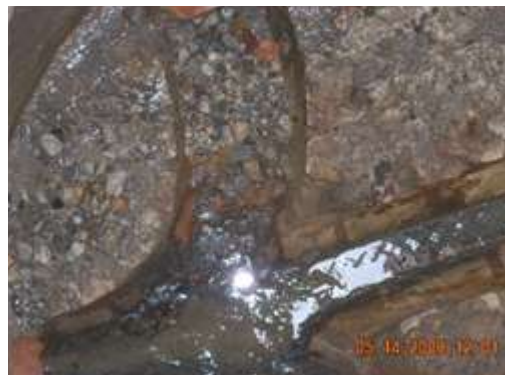
Defect 4

Condition: ☐ Sound ☐ Cracked ☐ Root Intrusion ☐ Deteriorated ☐ Leaks ☒ **Debris**

debris in channel

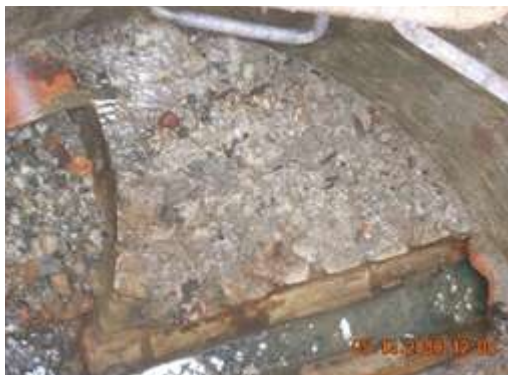
Defect 3

Condition: ☐ Sound ☐ Cracked ☐ Root Intrusion ☐ Deteriorated ☐ Leaks ☒ **Debris**

debris on bench

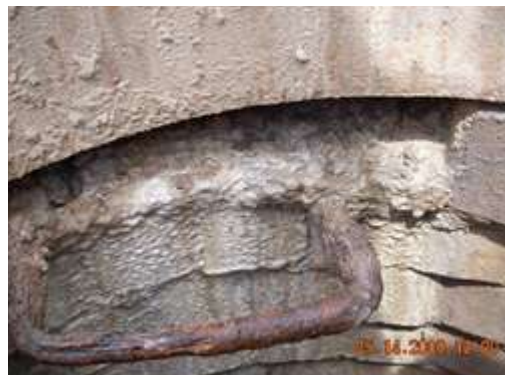
Defect 2

Condition: ☐ Sound ☐ Cracked ☐ Root Intrusion ☐ Loose Brick ☒ **Deteriorated**

deteriorated chimney

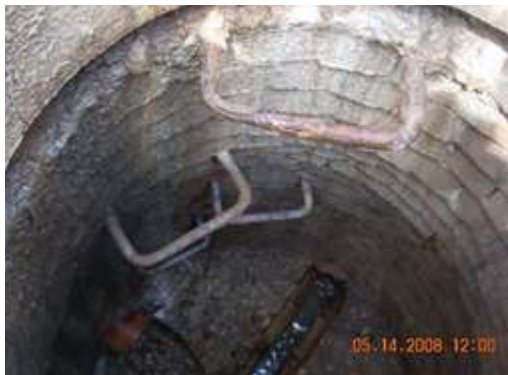
### Defect 1

**Steps** Count: **4** Missing: **0** ☒ **Corroded**

corroded steps

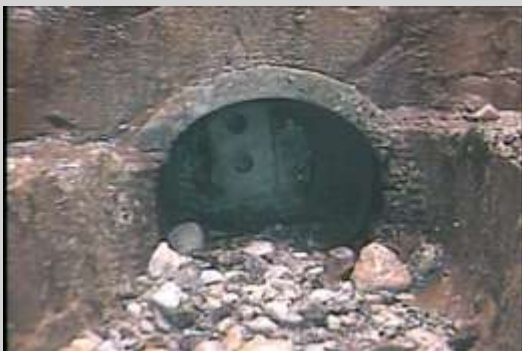
3 O'Clock Inflow

Pipe Height: **3.6** (in.) Rod and Bar (Angled)  
Pipe Material: **Clay** ☐ Pipe Lined  
Invert Depth: **0.00** (ft.) Flow Characteristics: **None**  
Deposits: ☐ None ☒ **Mud** ☐ Sludge ☐ Debris ☐ Grease  
Silt Depth: **3** (in.) Deposits Extent: **Medium**  
Infiltration: **None** Pipe Seal Cond: **Sound**

Connects To: **Stub connection / abandoned**

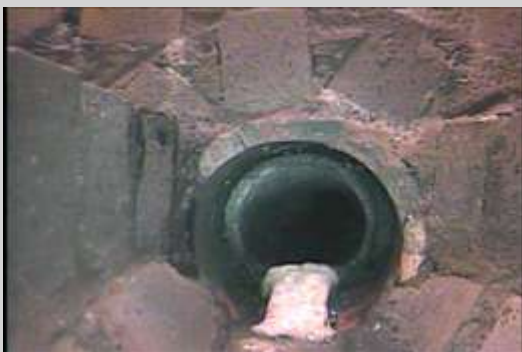
9 O'Clock Inflow

Deposits: ☐ None ☐ Mud ☐ Sludge ☒ **Debris** ☐ Grease

Silt Depth: **1** (in.) Deposits Extent: **Light**
